*The Holmes Safety Association*

# **BULLETIN**

*February 1999*

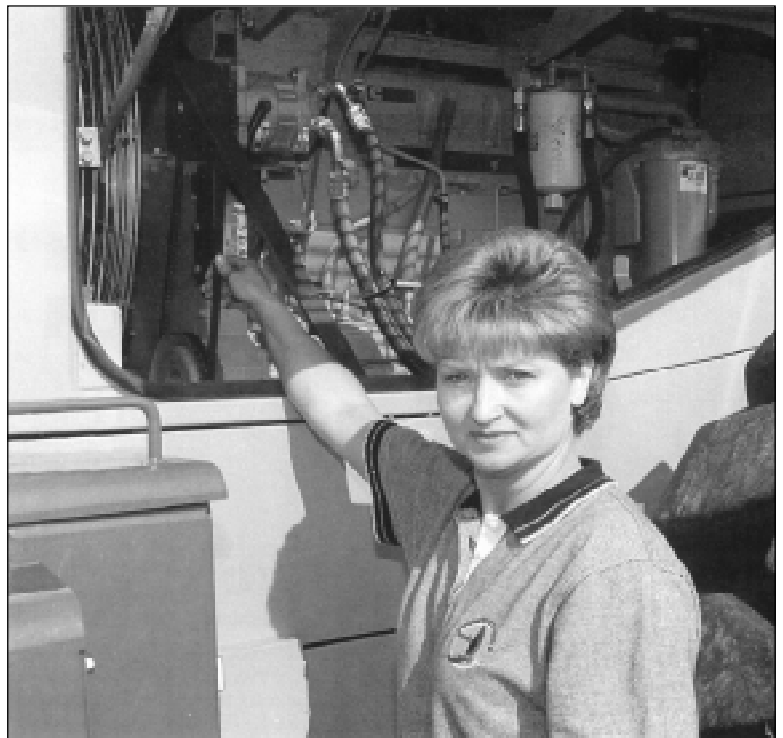
*Fonda Wood, Sales Trainer at the Komatsu Training Center, says checking belt tension and wear should be part of your morning walkaround.*

“It’s a good idea to feel the belts and hoses,” said Fonda Wood, a sales instructor at the Training Center. “You want to make sure there are no cracks and that they’re not too loose. You don’t want a lot of play in them. Make sure the pilot hoses are clamped.”

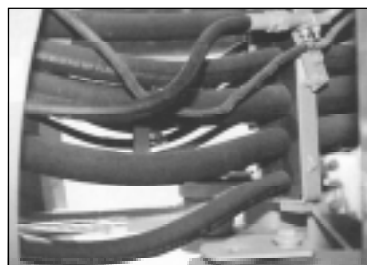
*If you suspect your air filter is clogging, you may need to check the dust evacuation tube. If it’s clogged, remove the obstruction.*

*A usual hose check will help prevent potentially dangerous and damaging leaks.*

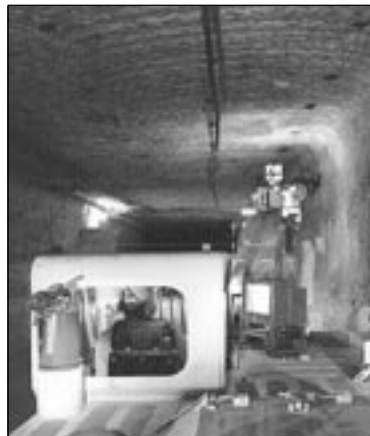
An underground scaling machine removes loose rock from walls and ceilings in the WIPP underground, assuring safe working conditions. A camera head is affixed to the boom, and the operator is able to view the action on a monitor screen. Mine operations personnel at WIPP are using a video system adapted to a mining machine for safer, more efficient scaling of walls (ribs) in the project's underground facility. Scaling of the mine walls is a routine part of ground control efforts in the WIPP underground, ensuring a continued safe environment. Mining technicians felt that scaling operations could be accomplished more efficiently

and effectively if the operator could actually see the chisel tip from his posi-

tion on the mining machine. As a result, a video system was adapted to the scaler, adding greater visibility and safety for the operator. Carlsbad Area Office Manager George Dials sees the innovation as just one more example of why WIPP has retained its impressive safety record: "Safety and efficiency are keys to the success of the WIPP program, and WIPP employees continuously respond to the challenges by devising better ways of doing business."
