The Holmes Safety Association

BULLETIN

April 1999

Laboratory assessment of the rock fragmentation process by continuous miners

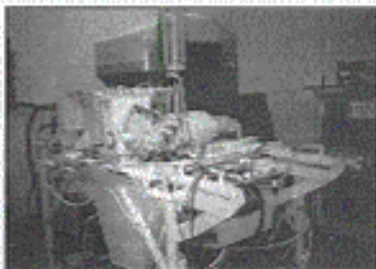
Figure 2.—
Typical
experimental
setup used in
the study.

Experimental setup and test procedure. The experimental setup utilized in this study was shown in Fig. 2. The observational parameters, such as cutting pressure, penetration pressure, cutting depth and AE counts, were recorded on a Model 1246 strip-chart recorder in real time. The study so far has involved performing experiments at a constant cutting drum rotational speed of 90 rpm on at least four different types of bits. Three tip angles were used while two tip sizes were also included at one specific tip angle. The tip angles included were 60°, 75° and 90°, and the tip sizes, i.e., small and large, both have a 75° angle tip. Three different bit spacings, namely, 25.4, 38.1 and 50.8 mm (1, 1.5, and 2 in.), were considered. The confinement pressure, both vertical and horizontal, on the rock block was held constant for all the experiments. For each experiment, the amount of height and weight losses of the bits, the respirable dust concen-

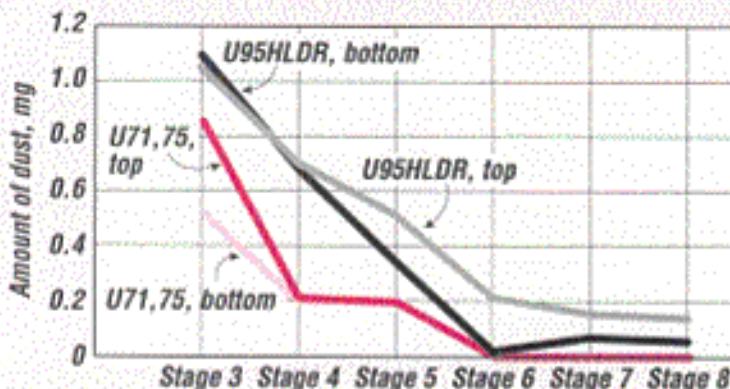
Figure 7.—Effect of bit tip size on respirable dust generated during cuts performed on three bits at 38.1 mm (1.5 in.) spacing and 75° tip angle (until the maximum depth).

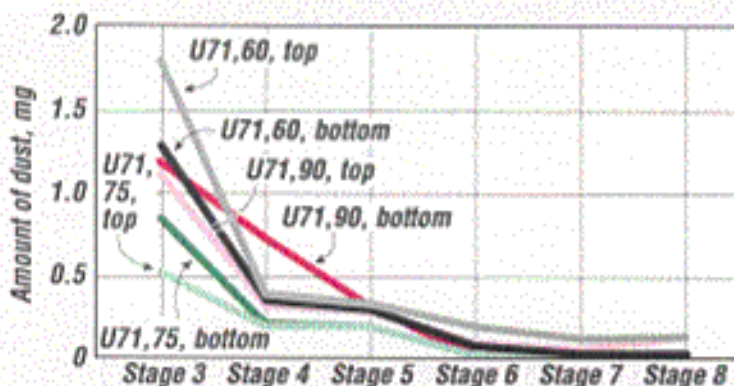
Figure 8.—Effect of bit spacing on respirable dust generated (three bits used, cuts were performed until the maximum depth at 38.1 mm (1.5 in.) spacing).

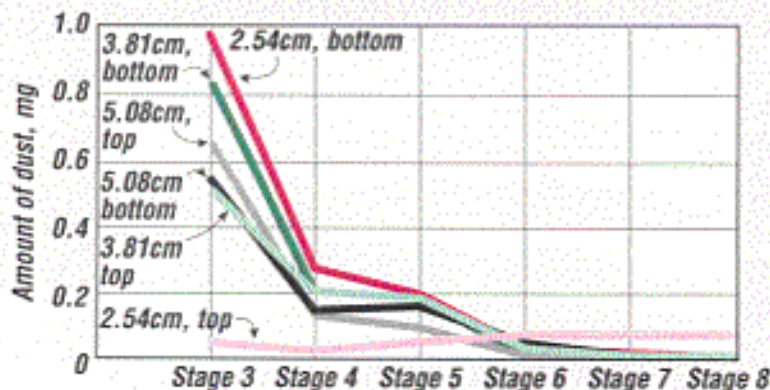
Figure 9 shows the respirable dust generated for the various cutting depths considered. Evidently, the smaller bit spacing resulted in more airborne dust generation. The anomaly in the results of the top cascade impactors could be attributed to the distance at which they were located from the cutting bit-rock interface.

Figure 9.—Effect of bit spacing on respirable dust generated (three bits used, cuts performed on U71,75 until the maximum depth).

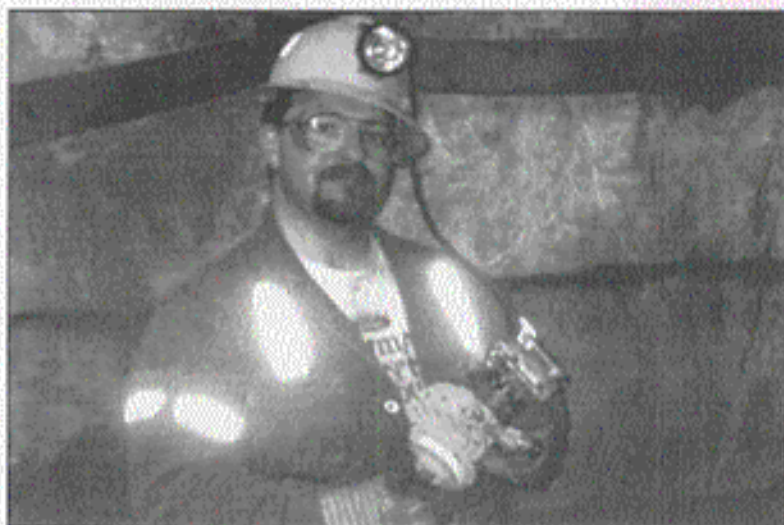
The operation recently started using a timed water spray system to keep down dust at drawpoints where ore is stockpiled. The timed spray replaces an old system that used to spray the muckpile continuously during a shift.

Michel Gervais, a production miner at Holt-McDermott demonstrates the timed spray system he developed.

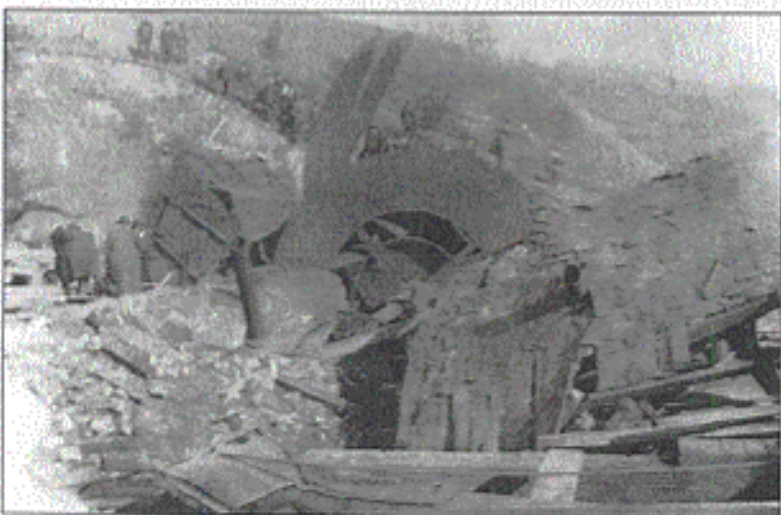
The wreckage of the fan and fan house around Mine No. 8.
